**GEOLOGIC FEATURES AND THEIR
POTENTIAL EFFECTS ON CONTAMINANT
MIGRATION, SANTA SUSANA FIELD
LABORATORY**

Howard G. Wilshire, Ph.D.

October 5, 2006

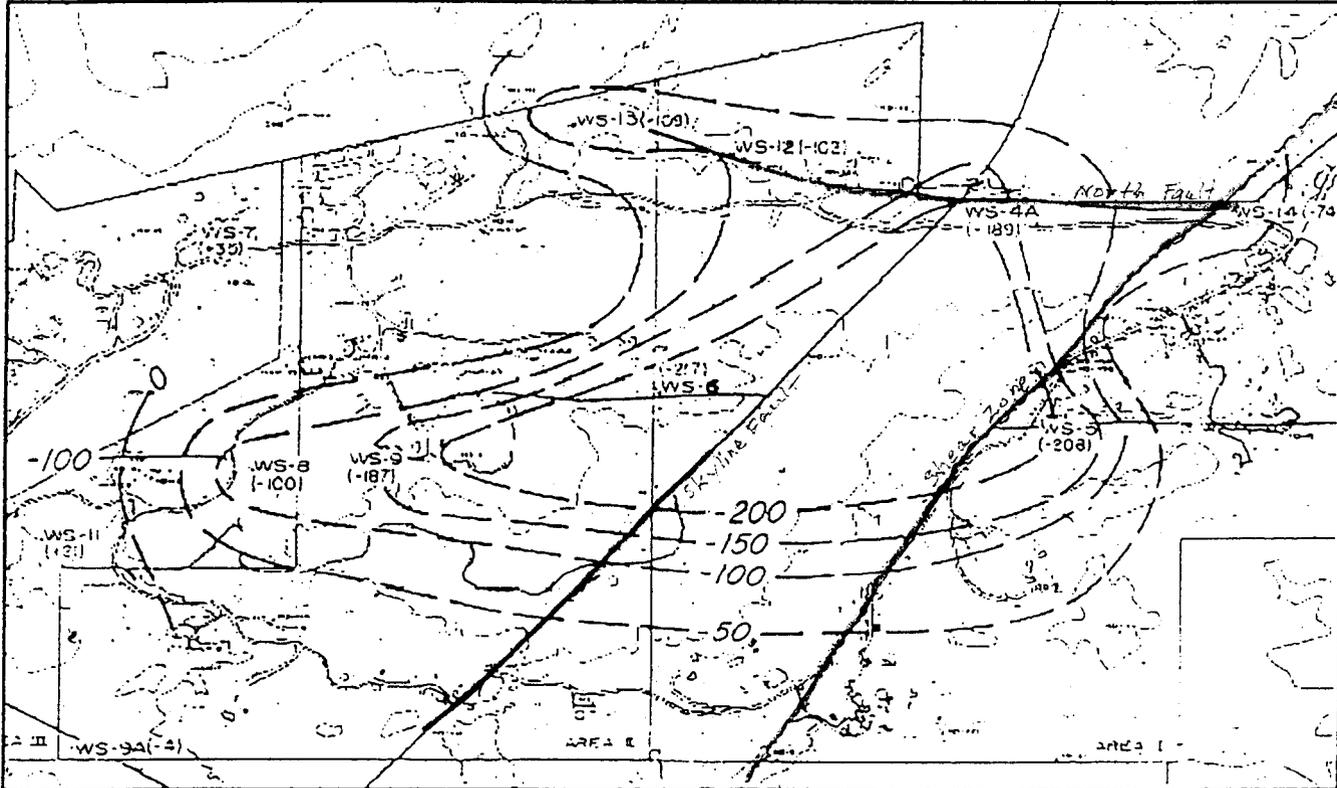
Exhibit 1. Drawdown contours (in feet) from water extraction, 1954-1997 in the northeastern part of the SSFL. From L. P. Smith (Haley & Aldrich), Appendix B, Conceptual Site Model, Santa Susana Field Laboratory, Hydrogeology Summary Report (April 2000), Figure 1.9.

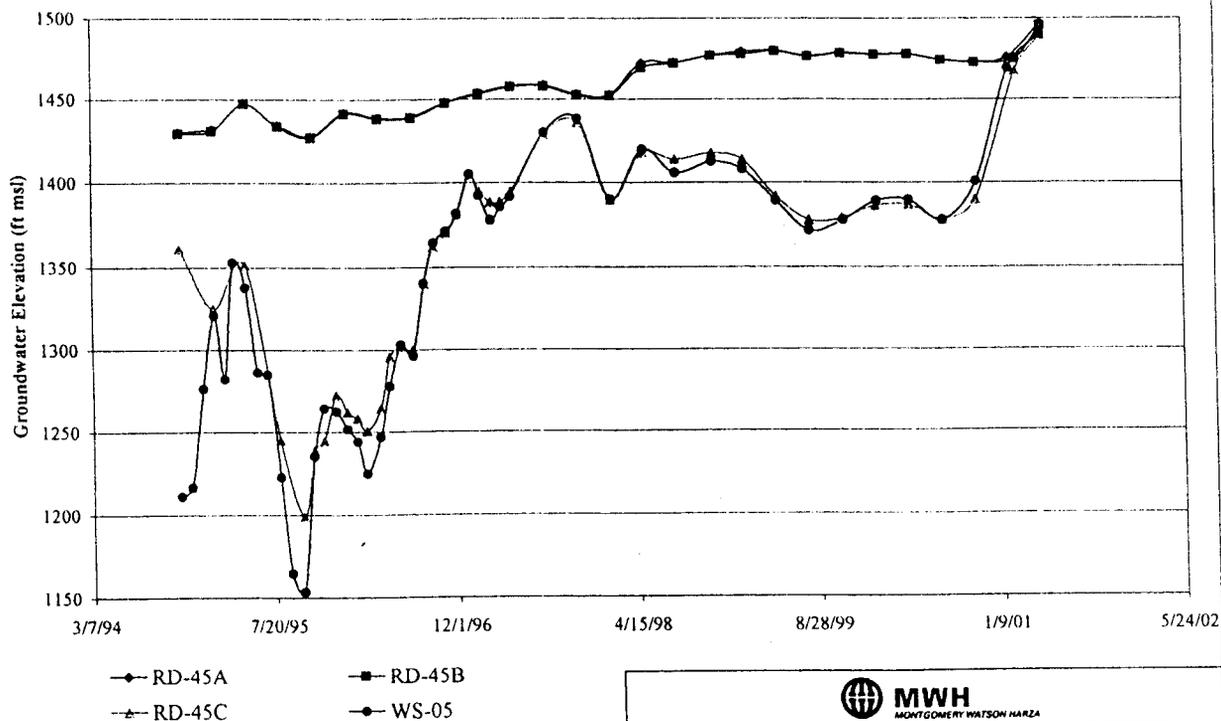
MWH
MONTGOMERY WATSON HARZA
 ROCKETDYNE PROPULSION AND POWER
 SANTA SUSANA FIELD LABORATORY
 VENTURA COUNTY, CALIFORNIA
LONG-TERM HYDROGRAPH OF THE RD-45 CLUSTER AND WS-5
 FIGURE 15

Exhibit 2. Hydrographs, 1994-2001, for wells WS-5, RD-45A, RD-45B, and RD-45C. From MWH, Technical Memorandum, Geologic Characterization of the Eastern Portion of the Santa Susana Field Laboratory (February 2002), Figure 15. Note faults differ from current representations.

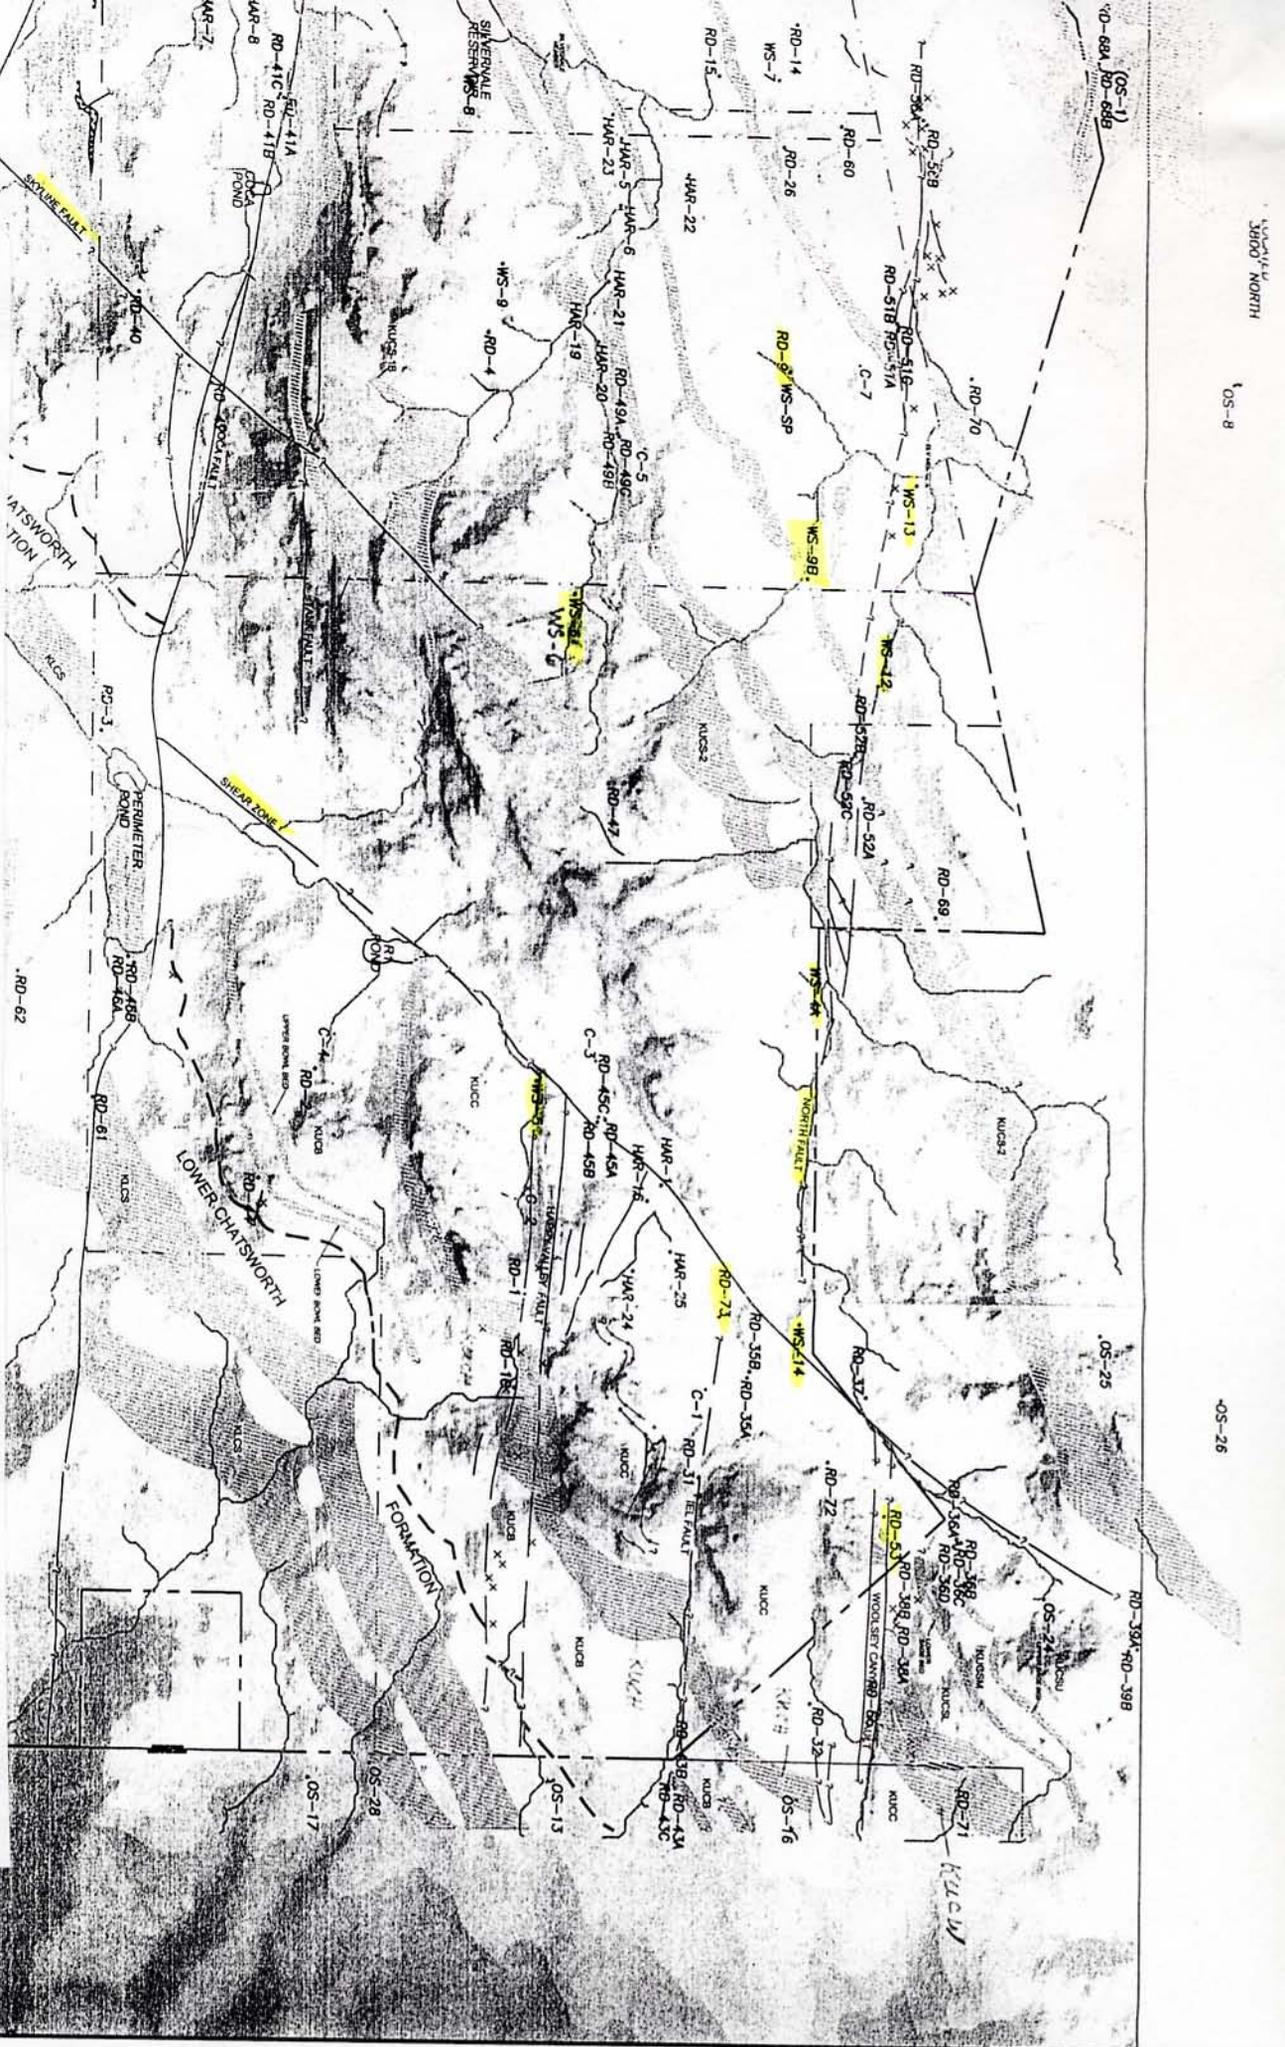
Exhibit 4. Portion of SSFL, showing drawdown contours for 90-day (May to August 1997) pump test of RD-73 (from L. P. Smith (Haley & Aldrich), Appendix B, Conceptual Site Model, Santa Susana Field Laboratory, Hydrogeology Summary Report (April 2000), Figure 2.9), and locations of subsequently mapped Woolsey Canyon and IEL Faults and enlarged Happy Valley Fault Zone (from MWH, Near-Surface Groundwater Characterization Report, Santa Susana Field Laboratory (November 2003), Figure 2-9). A possible E-W fault passes very close to RD-72 and RD-32 (MWH, Technical Memorandum, Geologic Characterization of the Eastern Portion of the Santa Susana Field Laboratory (February 2002), p. 4-4). The video log of RD-32 logs fault indicators (Groundwater Resources Consultants, Well Compendium (September 20, 1995); no logs available for RD-72.

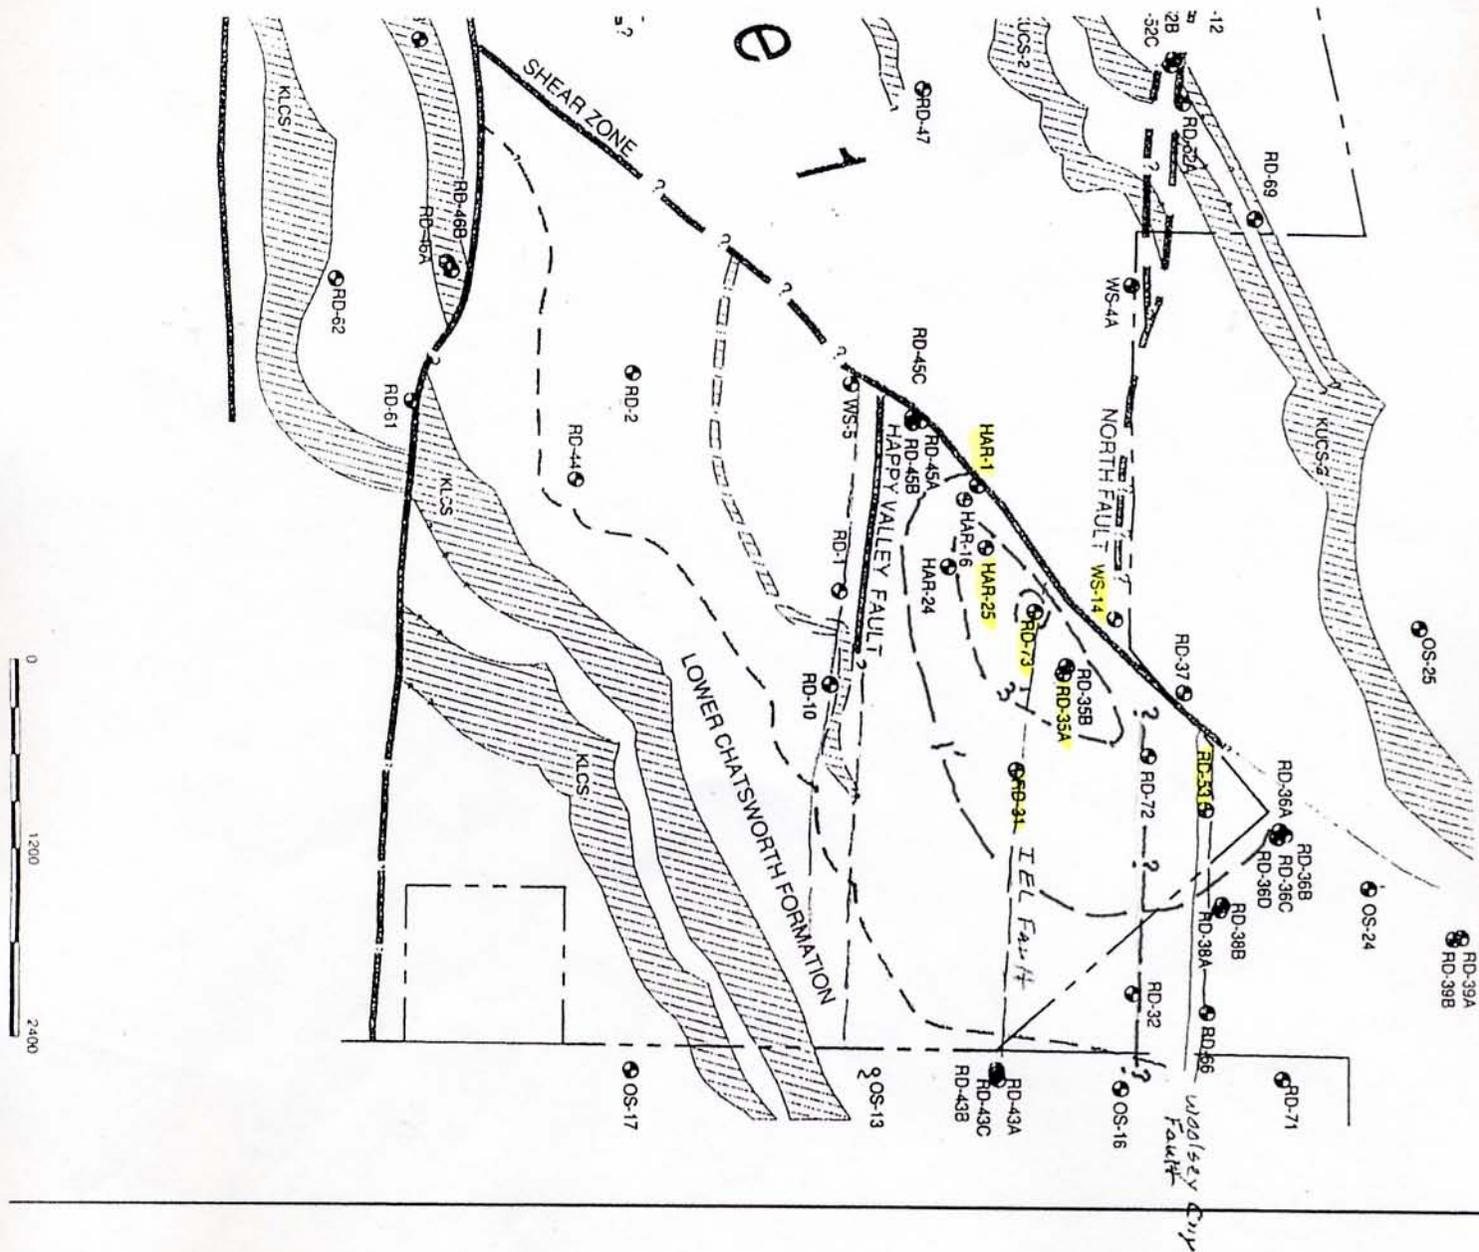
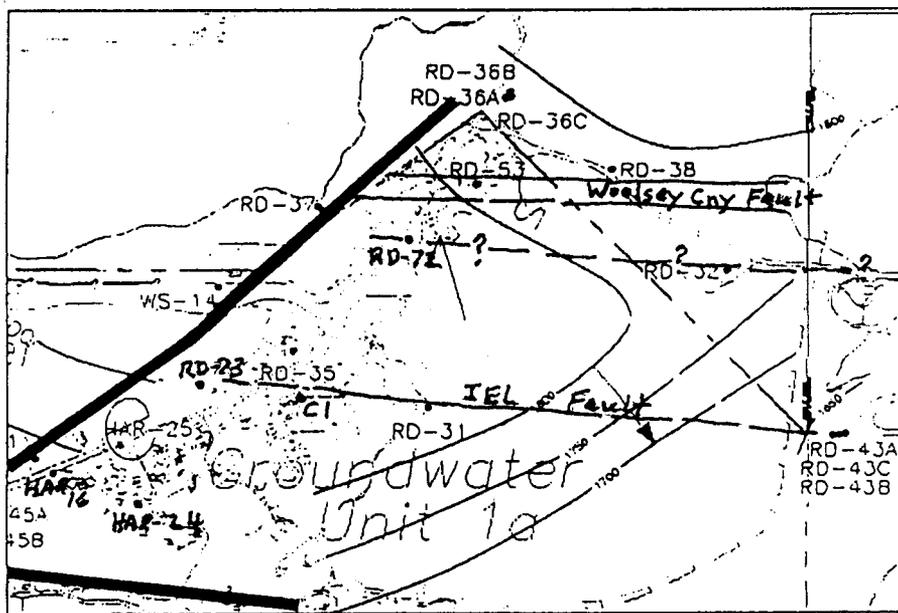
Exhibit 5. Portion of SSFL, showing water level contours for Groundwater Unit 1a as recognized in 2000 (from L. P. Smith (Haley & Aldrich), Appendix B, Conceptual Site Model, Santa Susana Field Laboratory, Hydrogeology Summary Report (April 2000), Figure 3.2), and locations of subsequently mapped Woolsey Canyon and IEL Faults and enlarged Happy Valley Fault Zone (from MWH, Near-Surface Groundwater Characterization Report, Santa Susana Field Laboratory (November 2003), Figure 2-9). A possible E-W fault passes very close to RD-72 and RD-32 (MWH, Technical Memorandum, Geologic Characterization of the Eastern Portion of the Santa Susana Field Laboratory (February 2002), p. 4-4).

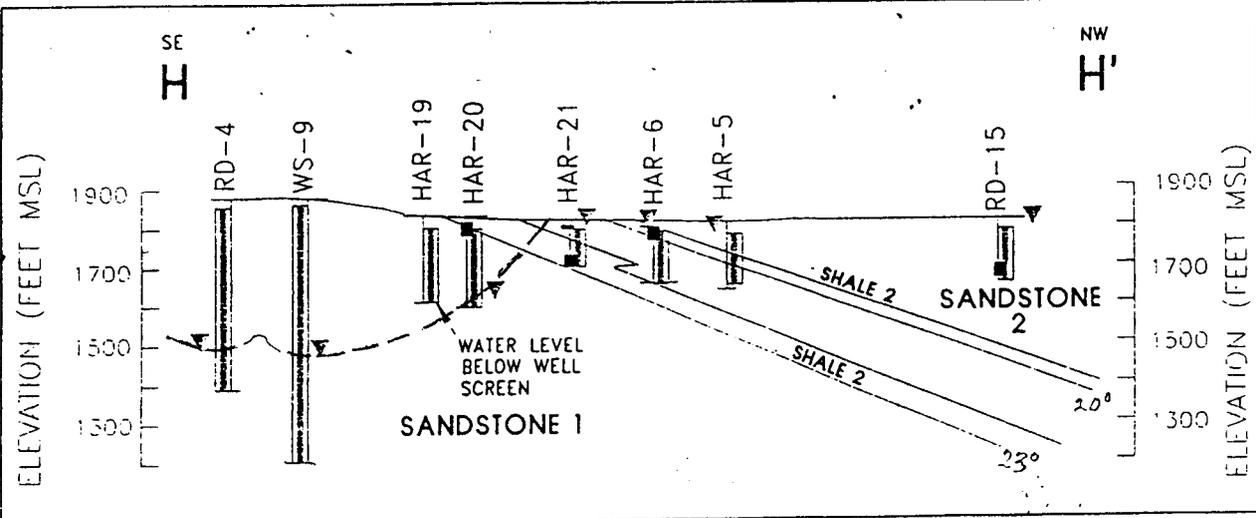
Exhibit 6. Section illustrating 200-300 feet difference in water elevations in wells screened on opposite sides of Shale 2 (from MWH, Technical Memorandum, Geologic Characterization of the Eastern Portion of the Santa Susana Field Laboratory (February 2002), p. 5-1). Note section line is viewed toward the south, contrary to normal practice.

Exhibit 6 illustrates the case that Shale-2 acts as an aquitard between Sandstones-1 and -2 (old designations), as seen in water levels in wells RD-4, WS-9, HAR-19, and HAR-20 screened in Sandstone-1, and HAR-21, HAR-6, HAR-5, and RD-15 screened in Sandstone-2. Wells RD-4 and WS-9 are pumped wells with water levels governed by long-term extraction. Wells screened in Sandstone-2 are about 200 to 300 feet higher than those screened in Sandstone-1. It should be noted that the section in Exhibit 6 is viewed toward the south, contrary to normal practice.⁹⁵ The section does not position HAR-20 and HAR-21 consistently with the rather complex representation of Shale-2 in Fig. 2-9 of the Near-Surface Groundwater study. In addition, the well distribution is a shotgun pattern, but no information is given on how the wells were projected to the section line. It also is not clear why other wells in the area were not used to assess the water level differences—wells not used that might represent Sandstone-1 conditions include RD-49A, RD-49B, RD-49C, and C-5, and those that might represent Sandstone-2 conditions, but which were not used, include HAR-22, HAR-23, and RD-16.

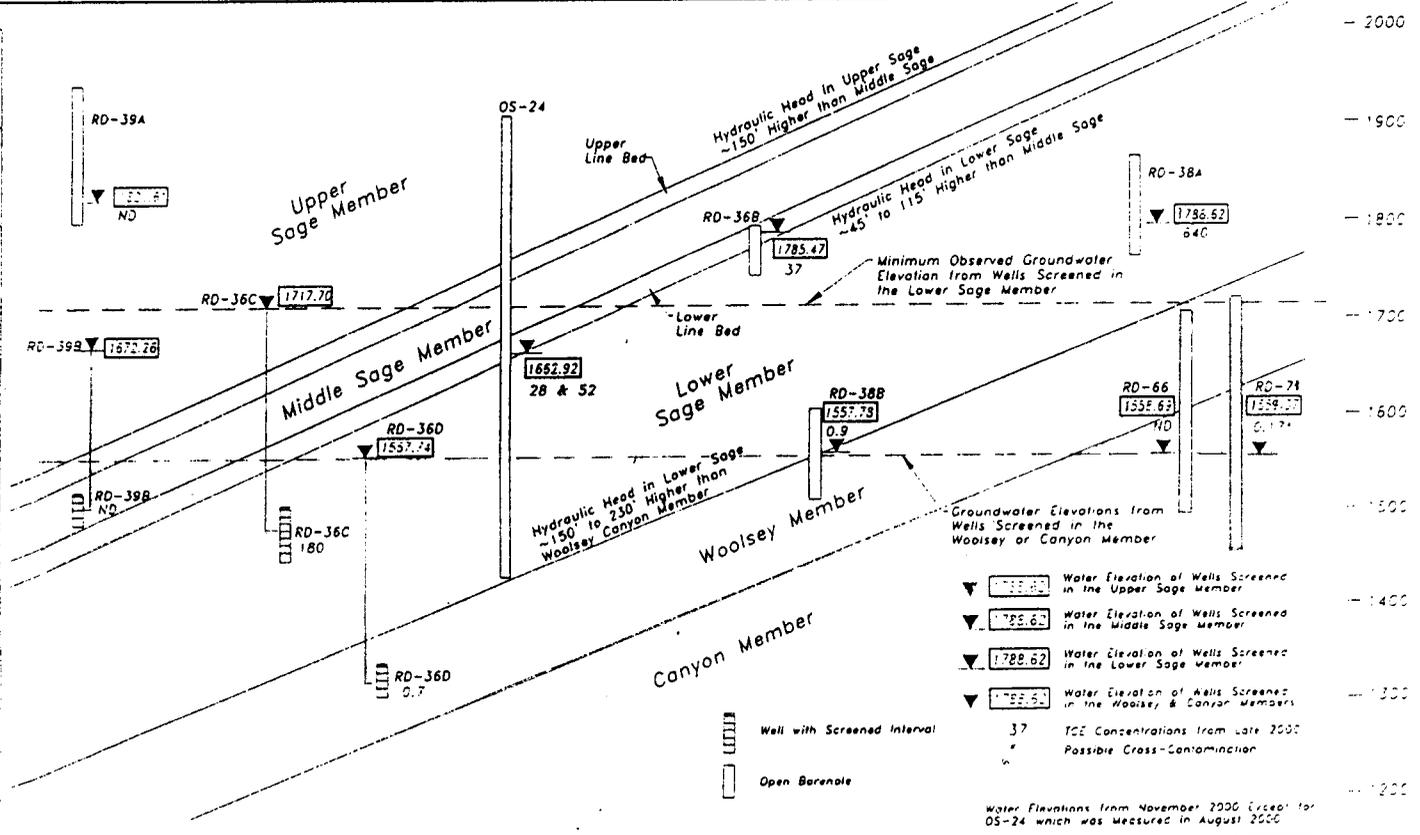
Exhibit 7. Diagrammatic representation of the stratigraphic positions of open intervals for wells RD-39A, RD-39B, RD-36C, RD-36D, OS-24, RD-36B, RD-38B, RD-38A, RD-66, and RD-71 (from MWH, Technical Memorandum, Geologic Characterization of the Eastern Portion of the Santa Susana Field Laboratory (February 2002), p. 5-6).
